Test Report

No. SHAEC1618755604

The following sample(s) was/were submitted and identified on behalf of the clients as : 3M 9080A

Halogen

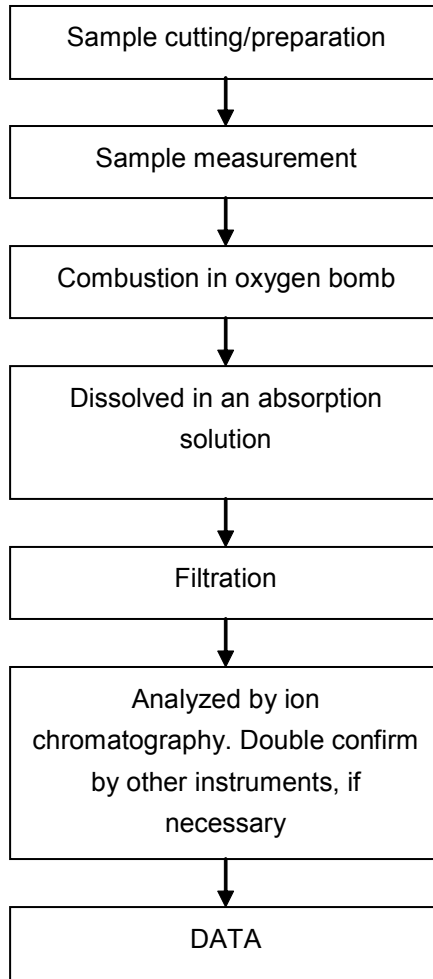
Halogen Testing (oxygen bomb) Flow Chart

Test Method : With reference to EN 14582: 2007, analysis was performed by Ion Chromatograph (IC).

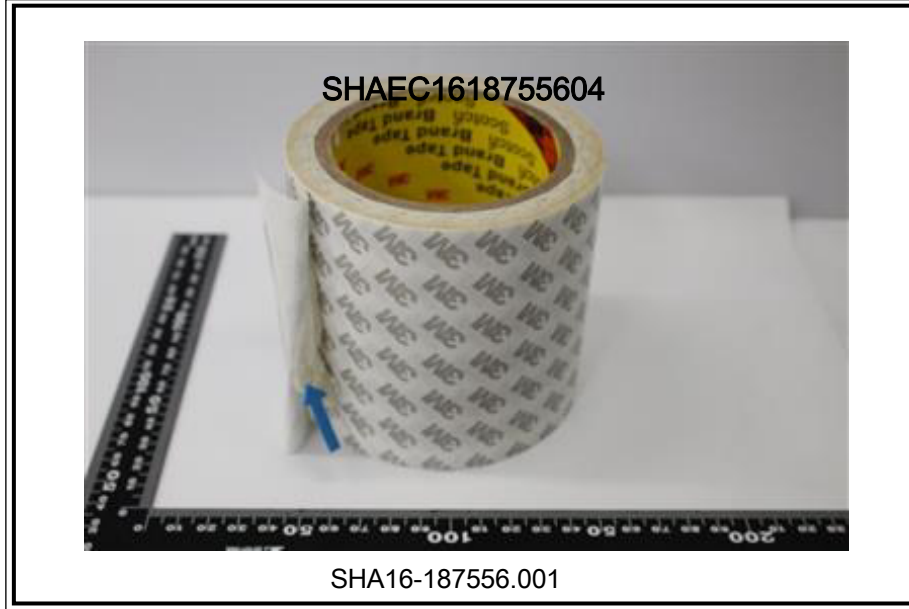
Sample photo:

| Specimen No. | SGS Sample ID | Description |
|---|---|---|
| SN1 | SHA16-187556.001 | Translucent adhesive film |
